NATIONAL ADVISORY COMMITTEE FOR AERONAUTICS

WARTIME REPORT

MEASUREMENTS IN FLIGHT OF THE STABILITY, LATERAL-
CONTROL, AND STALLING CHARACTERISTICS OF AN AIRPLANE
EQUIPPED WITH FULL-SPAN ZAP FLAPS AND
SPOILER-TYPE AILERONS

MEMORANDUM REPORT

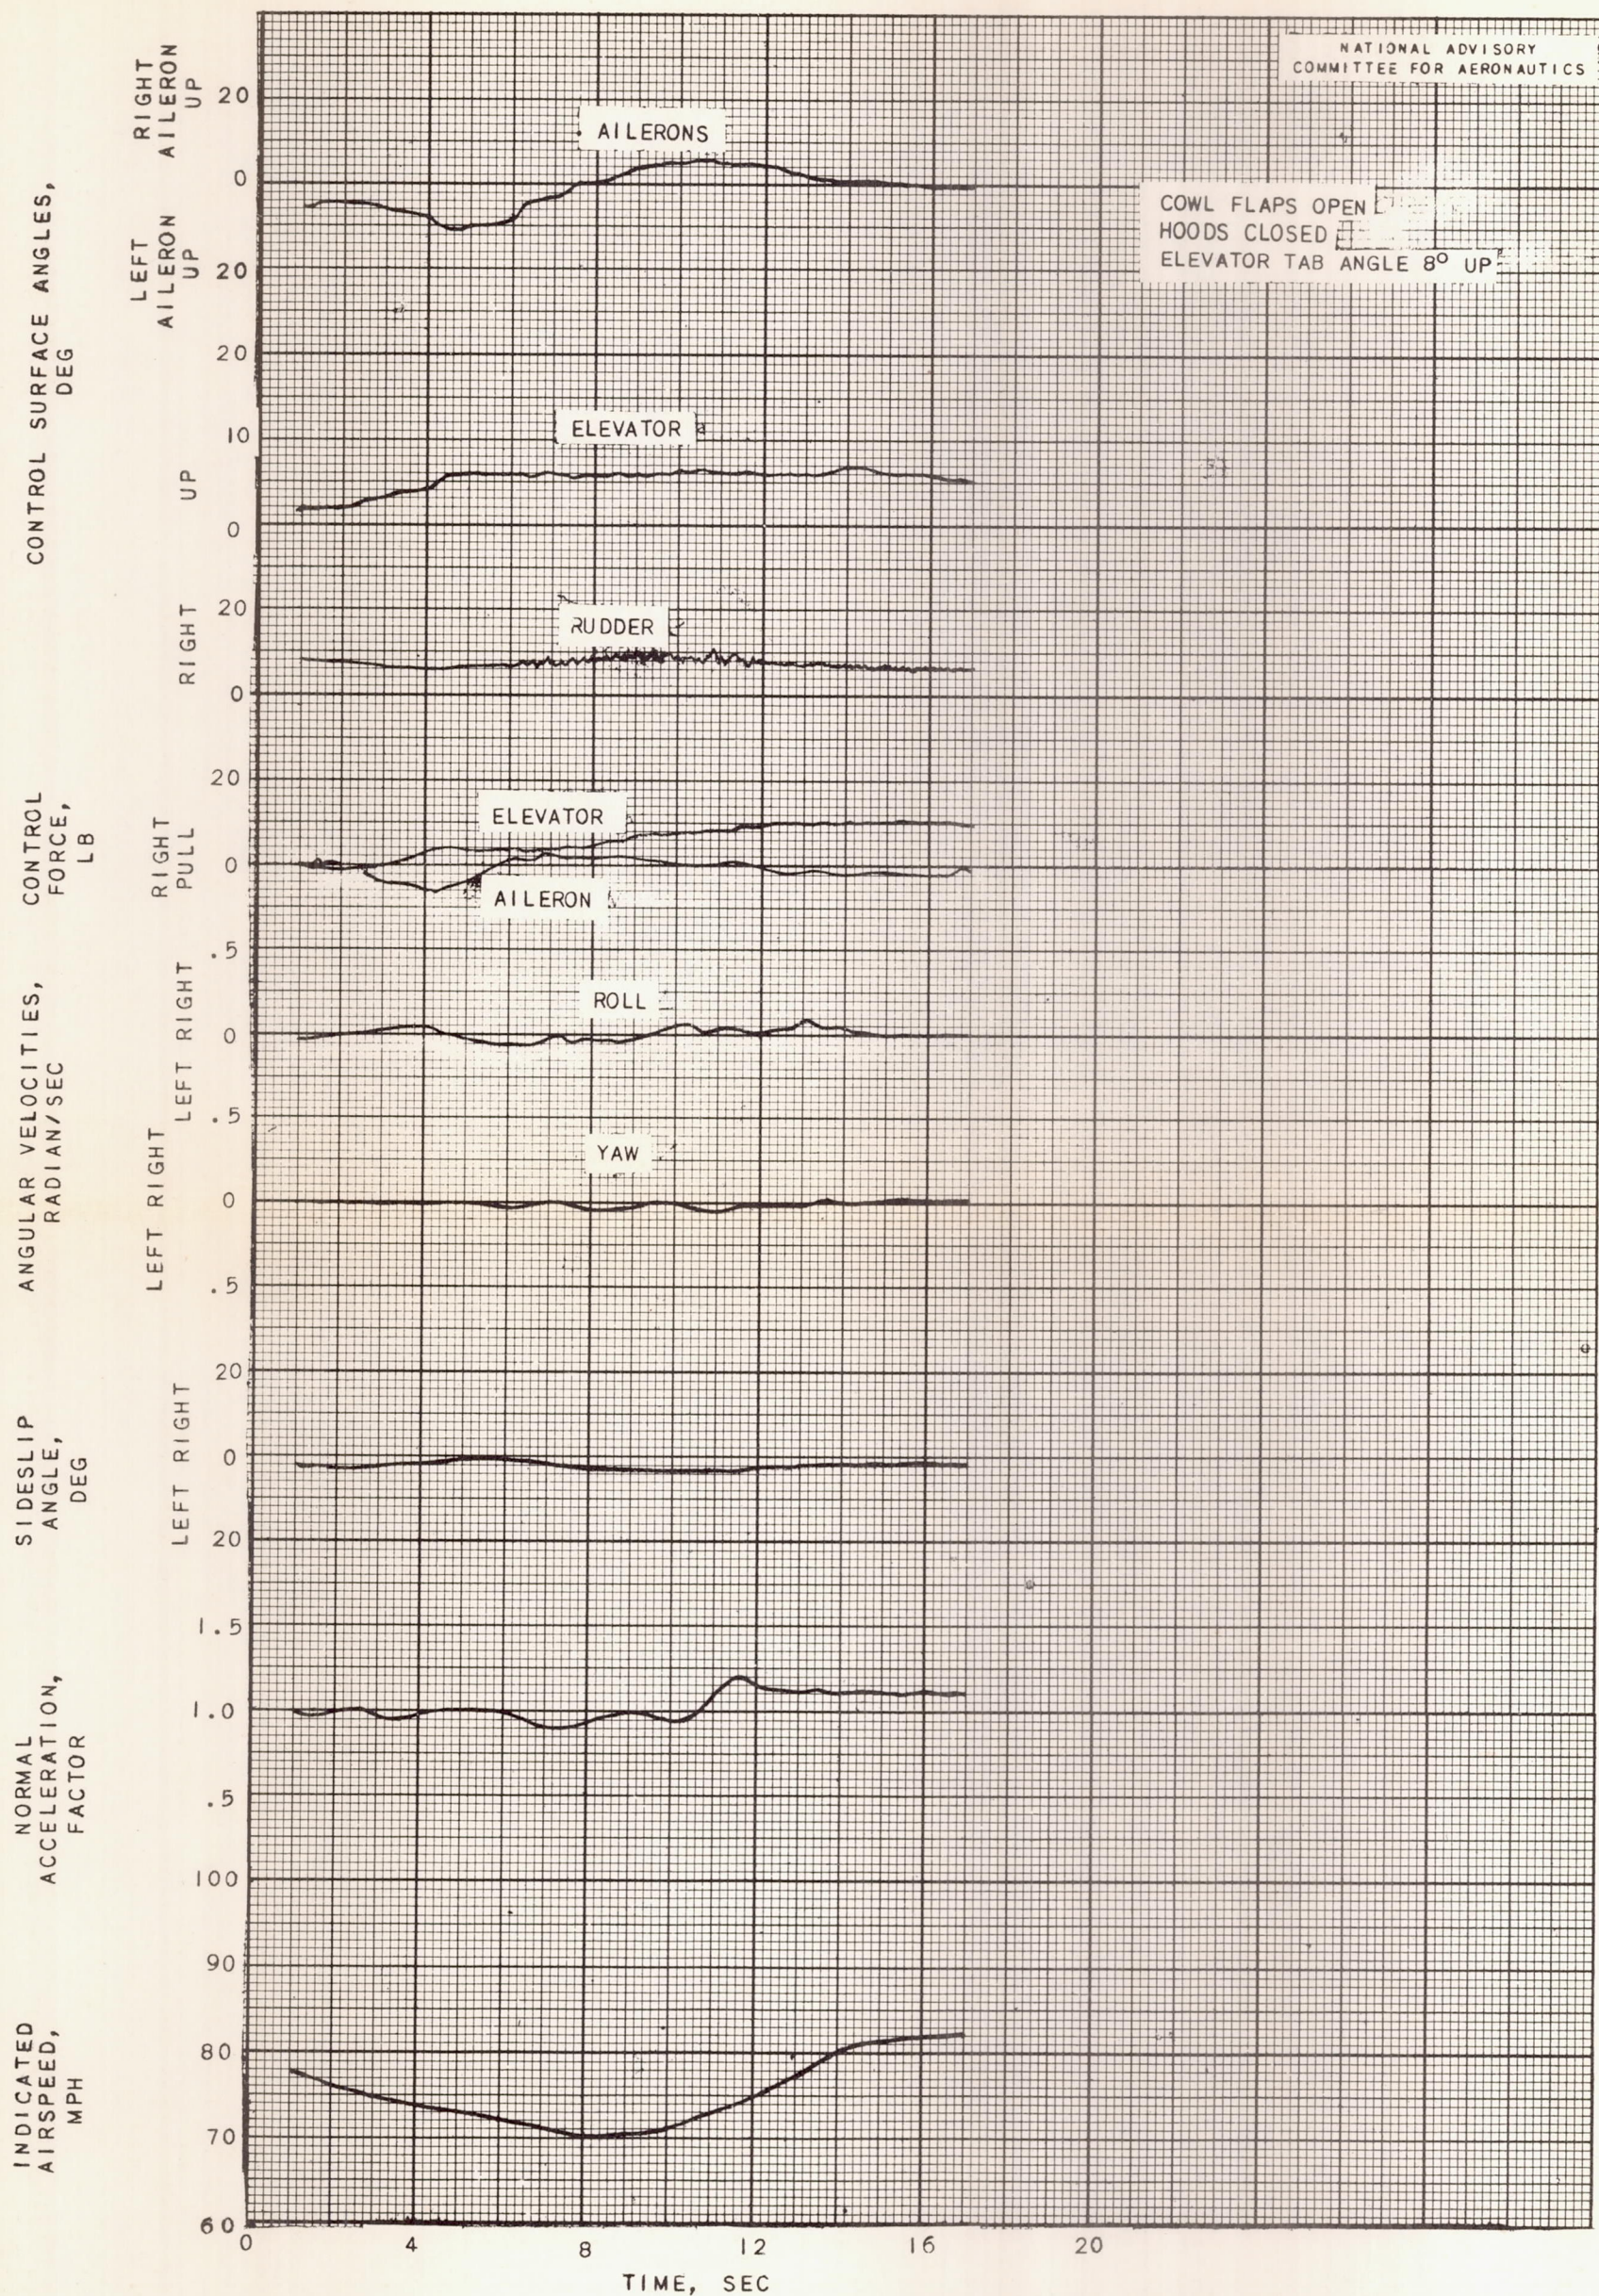
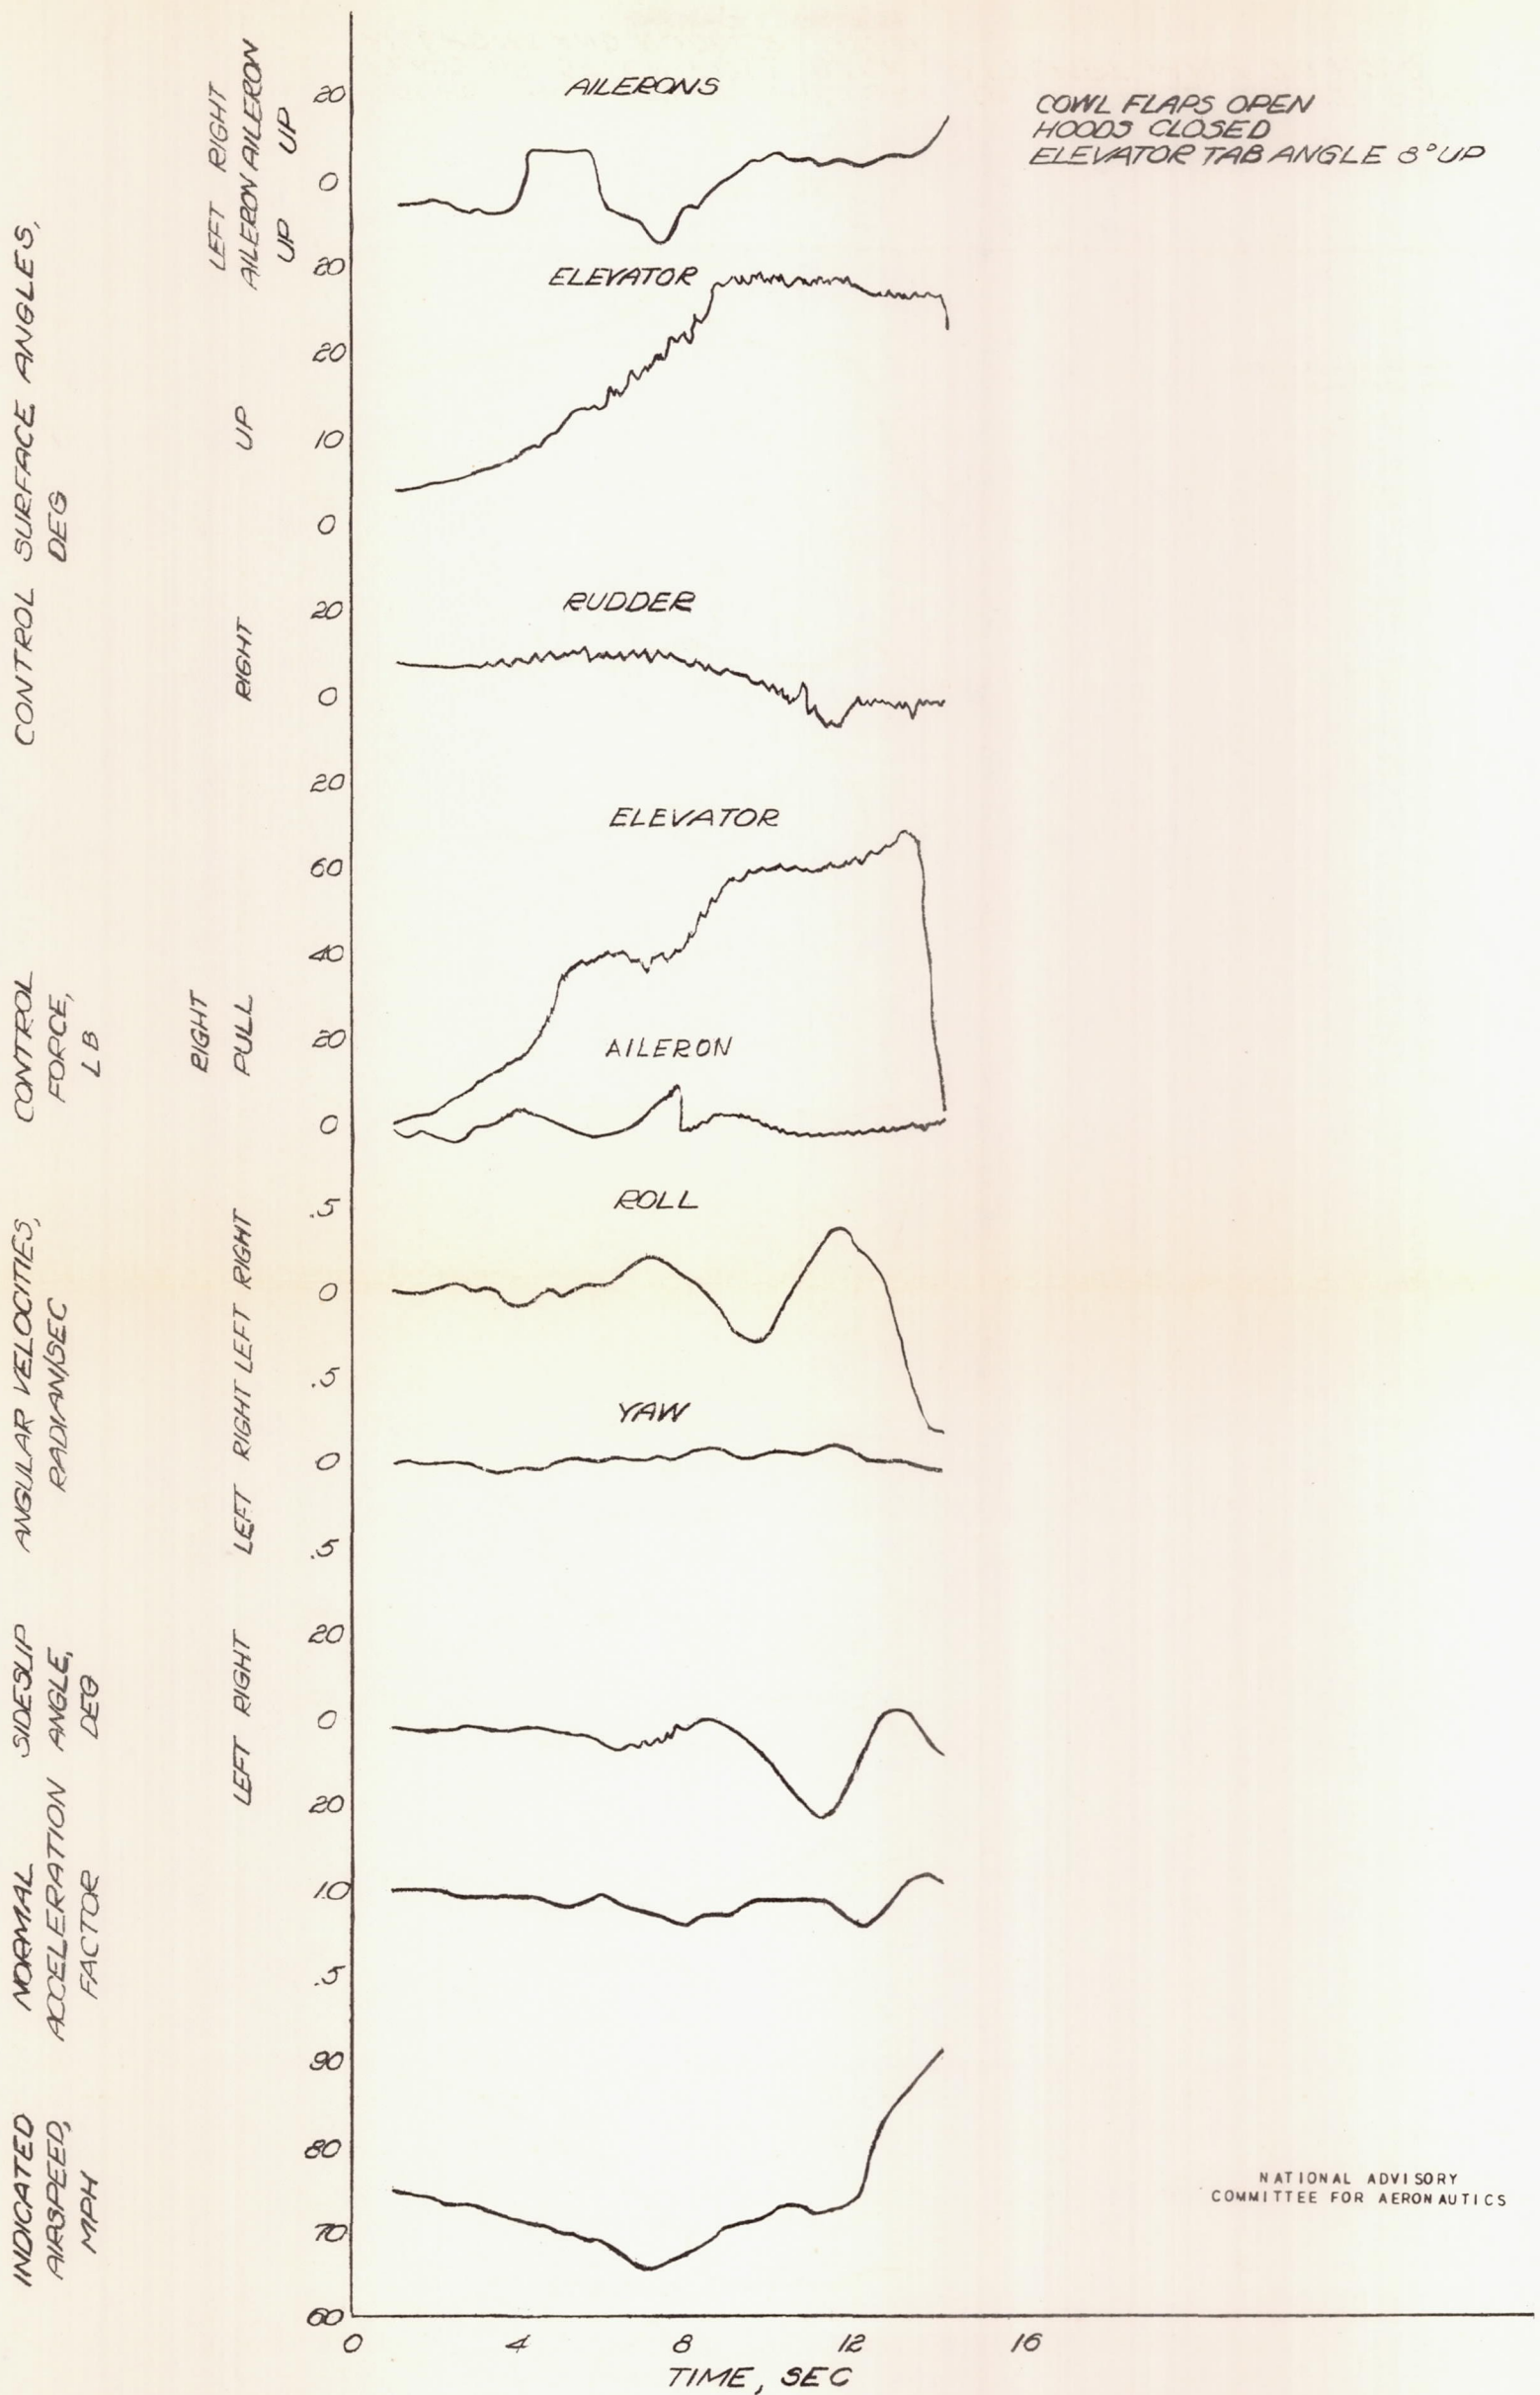
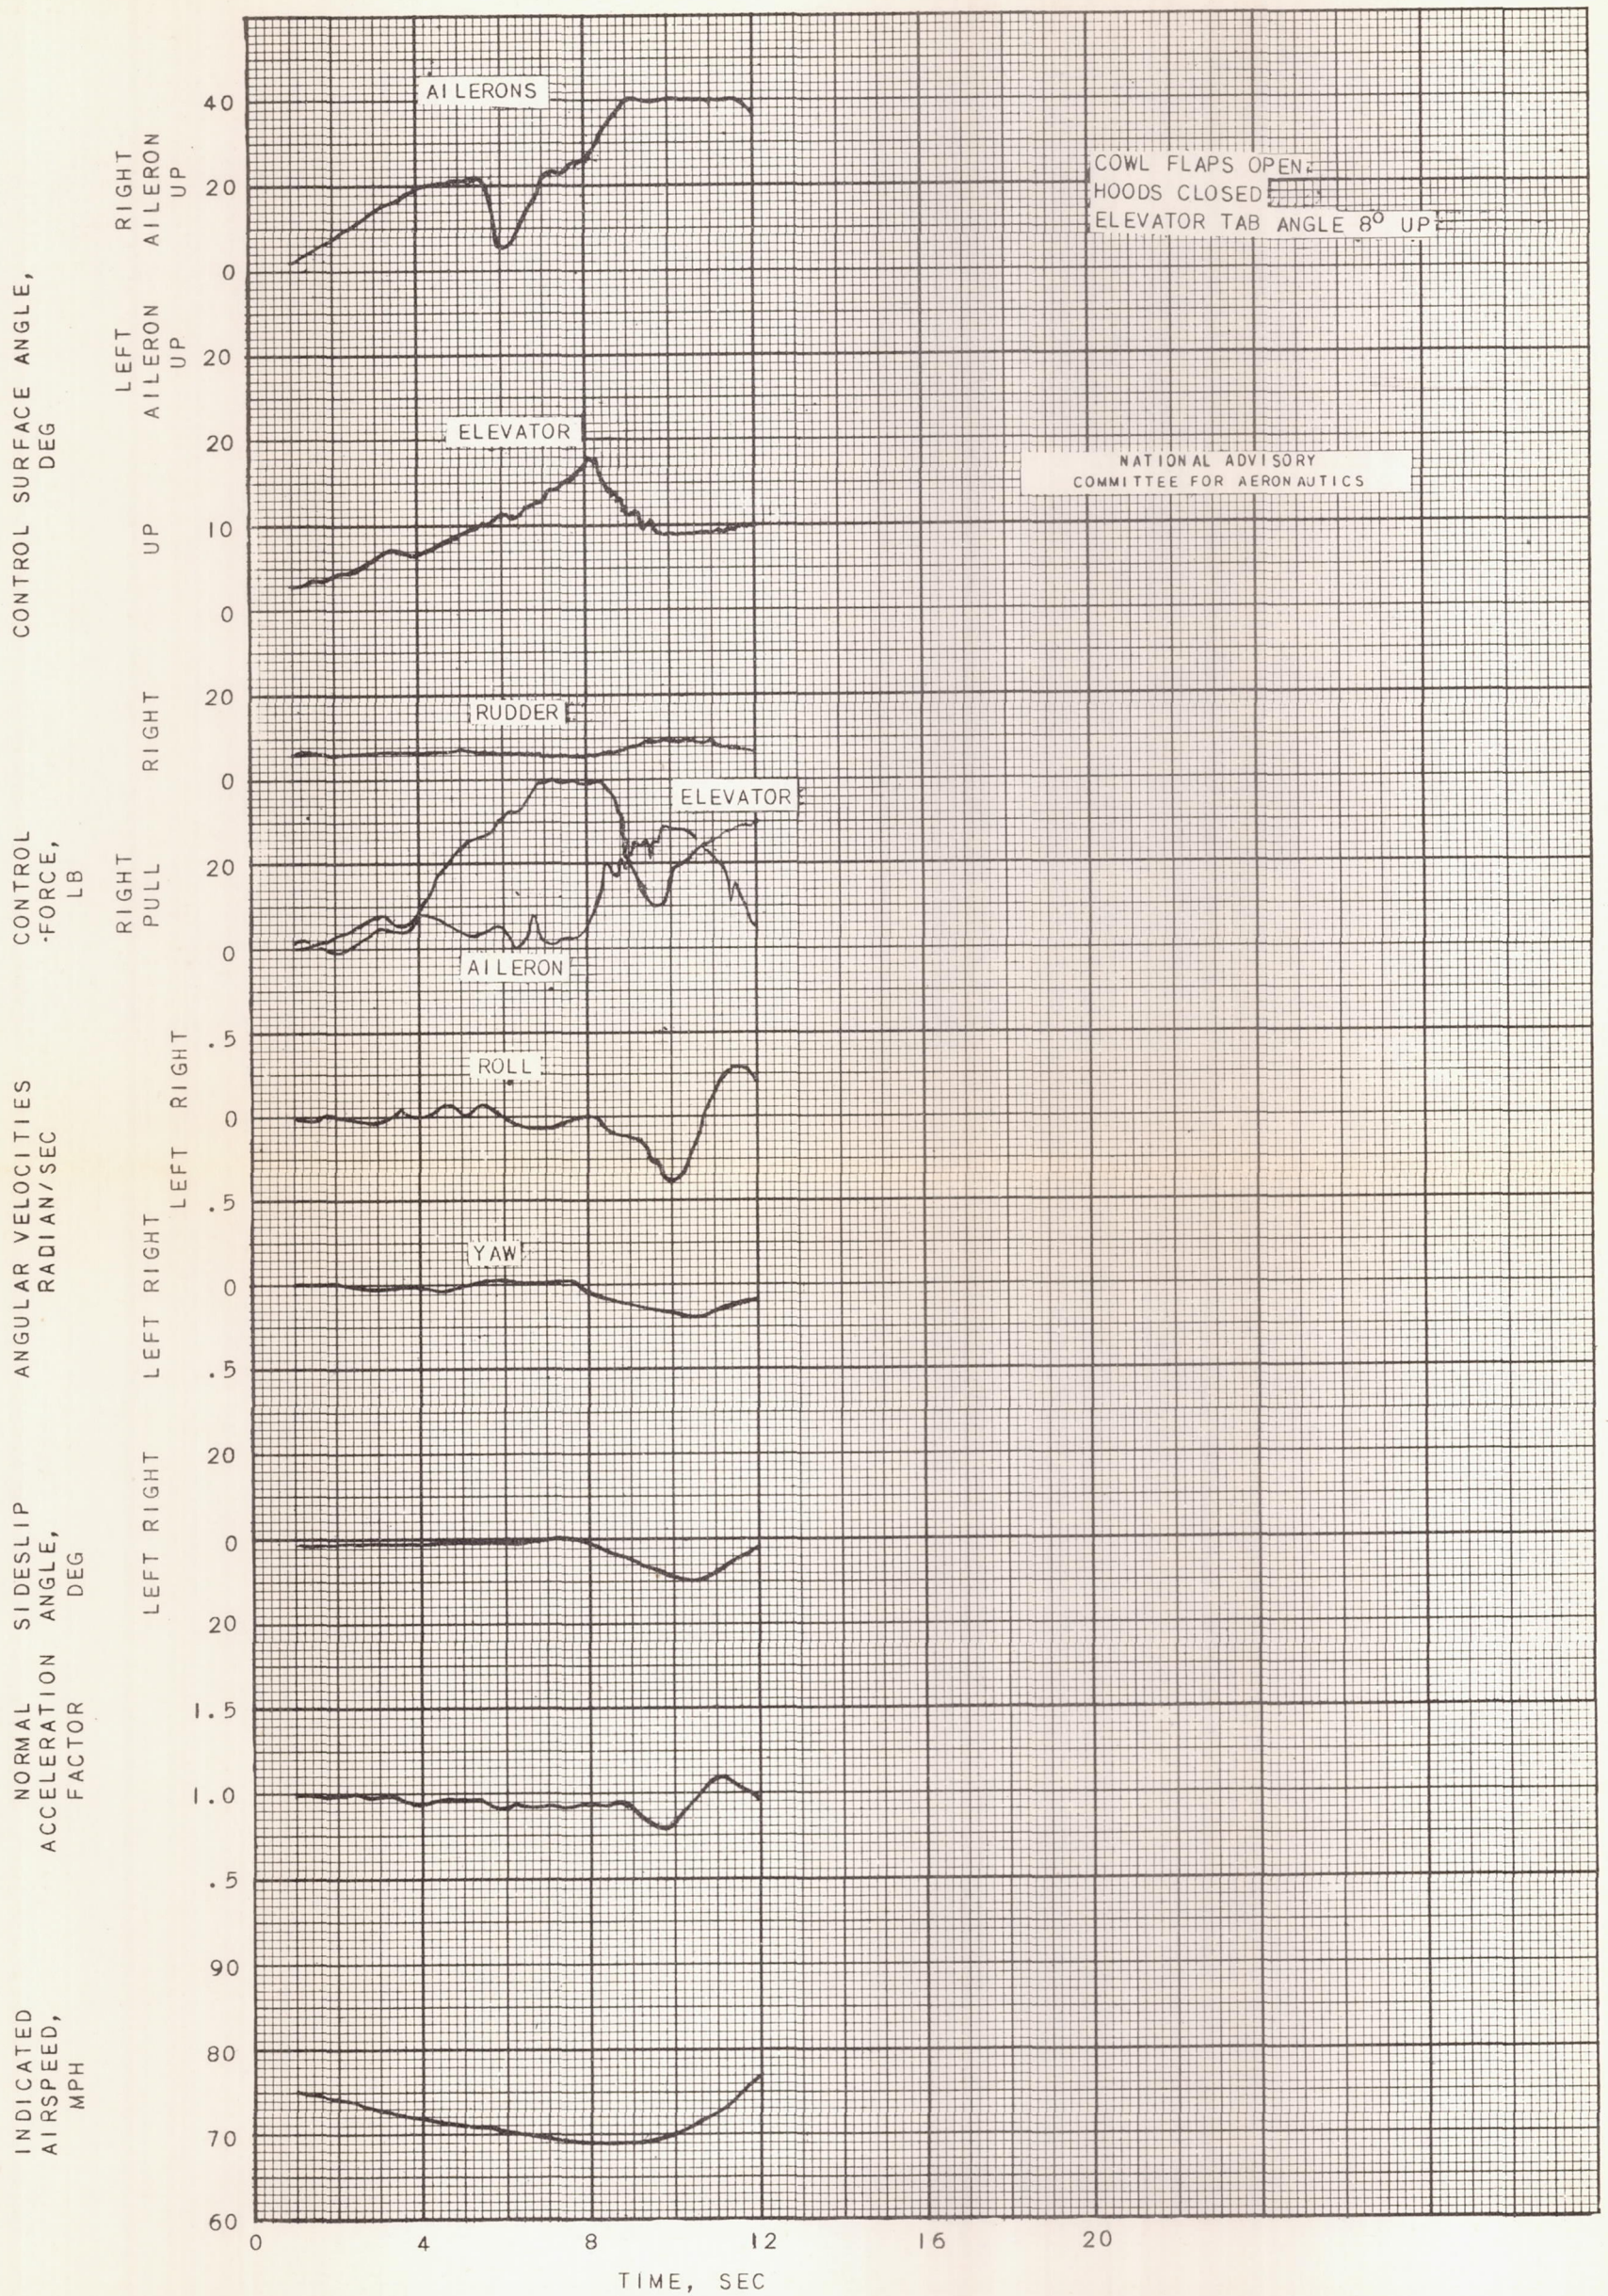
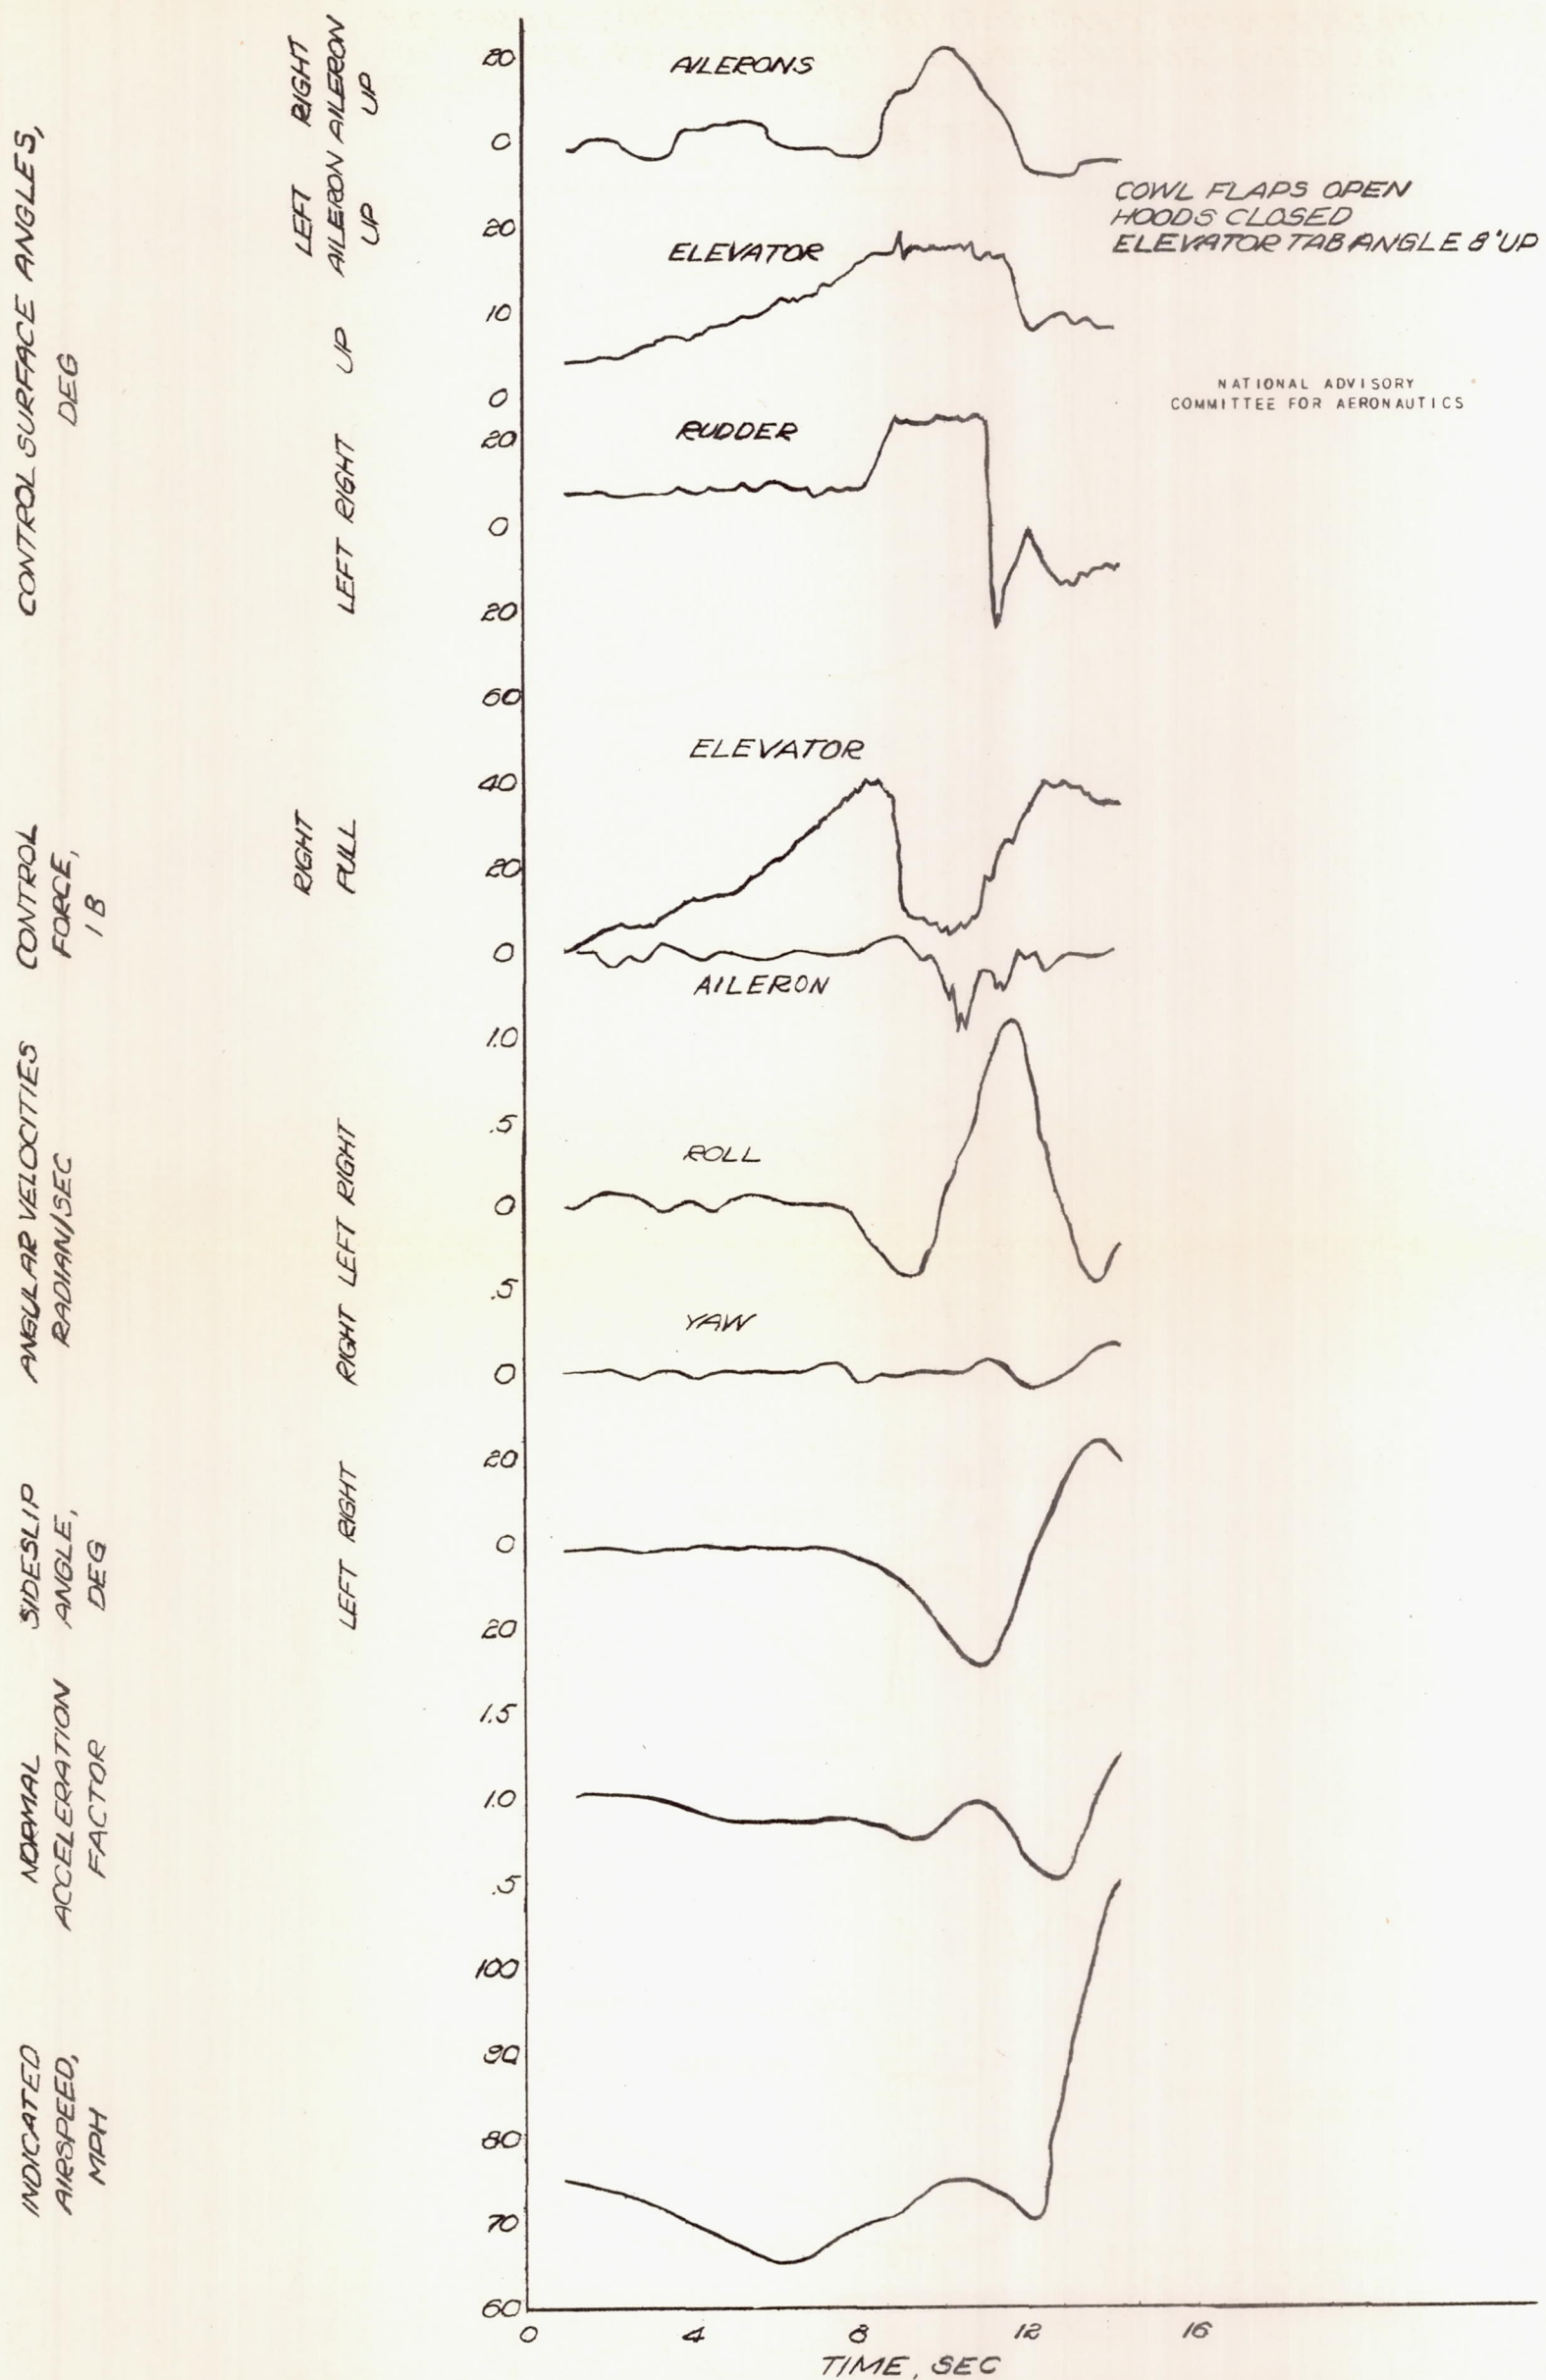
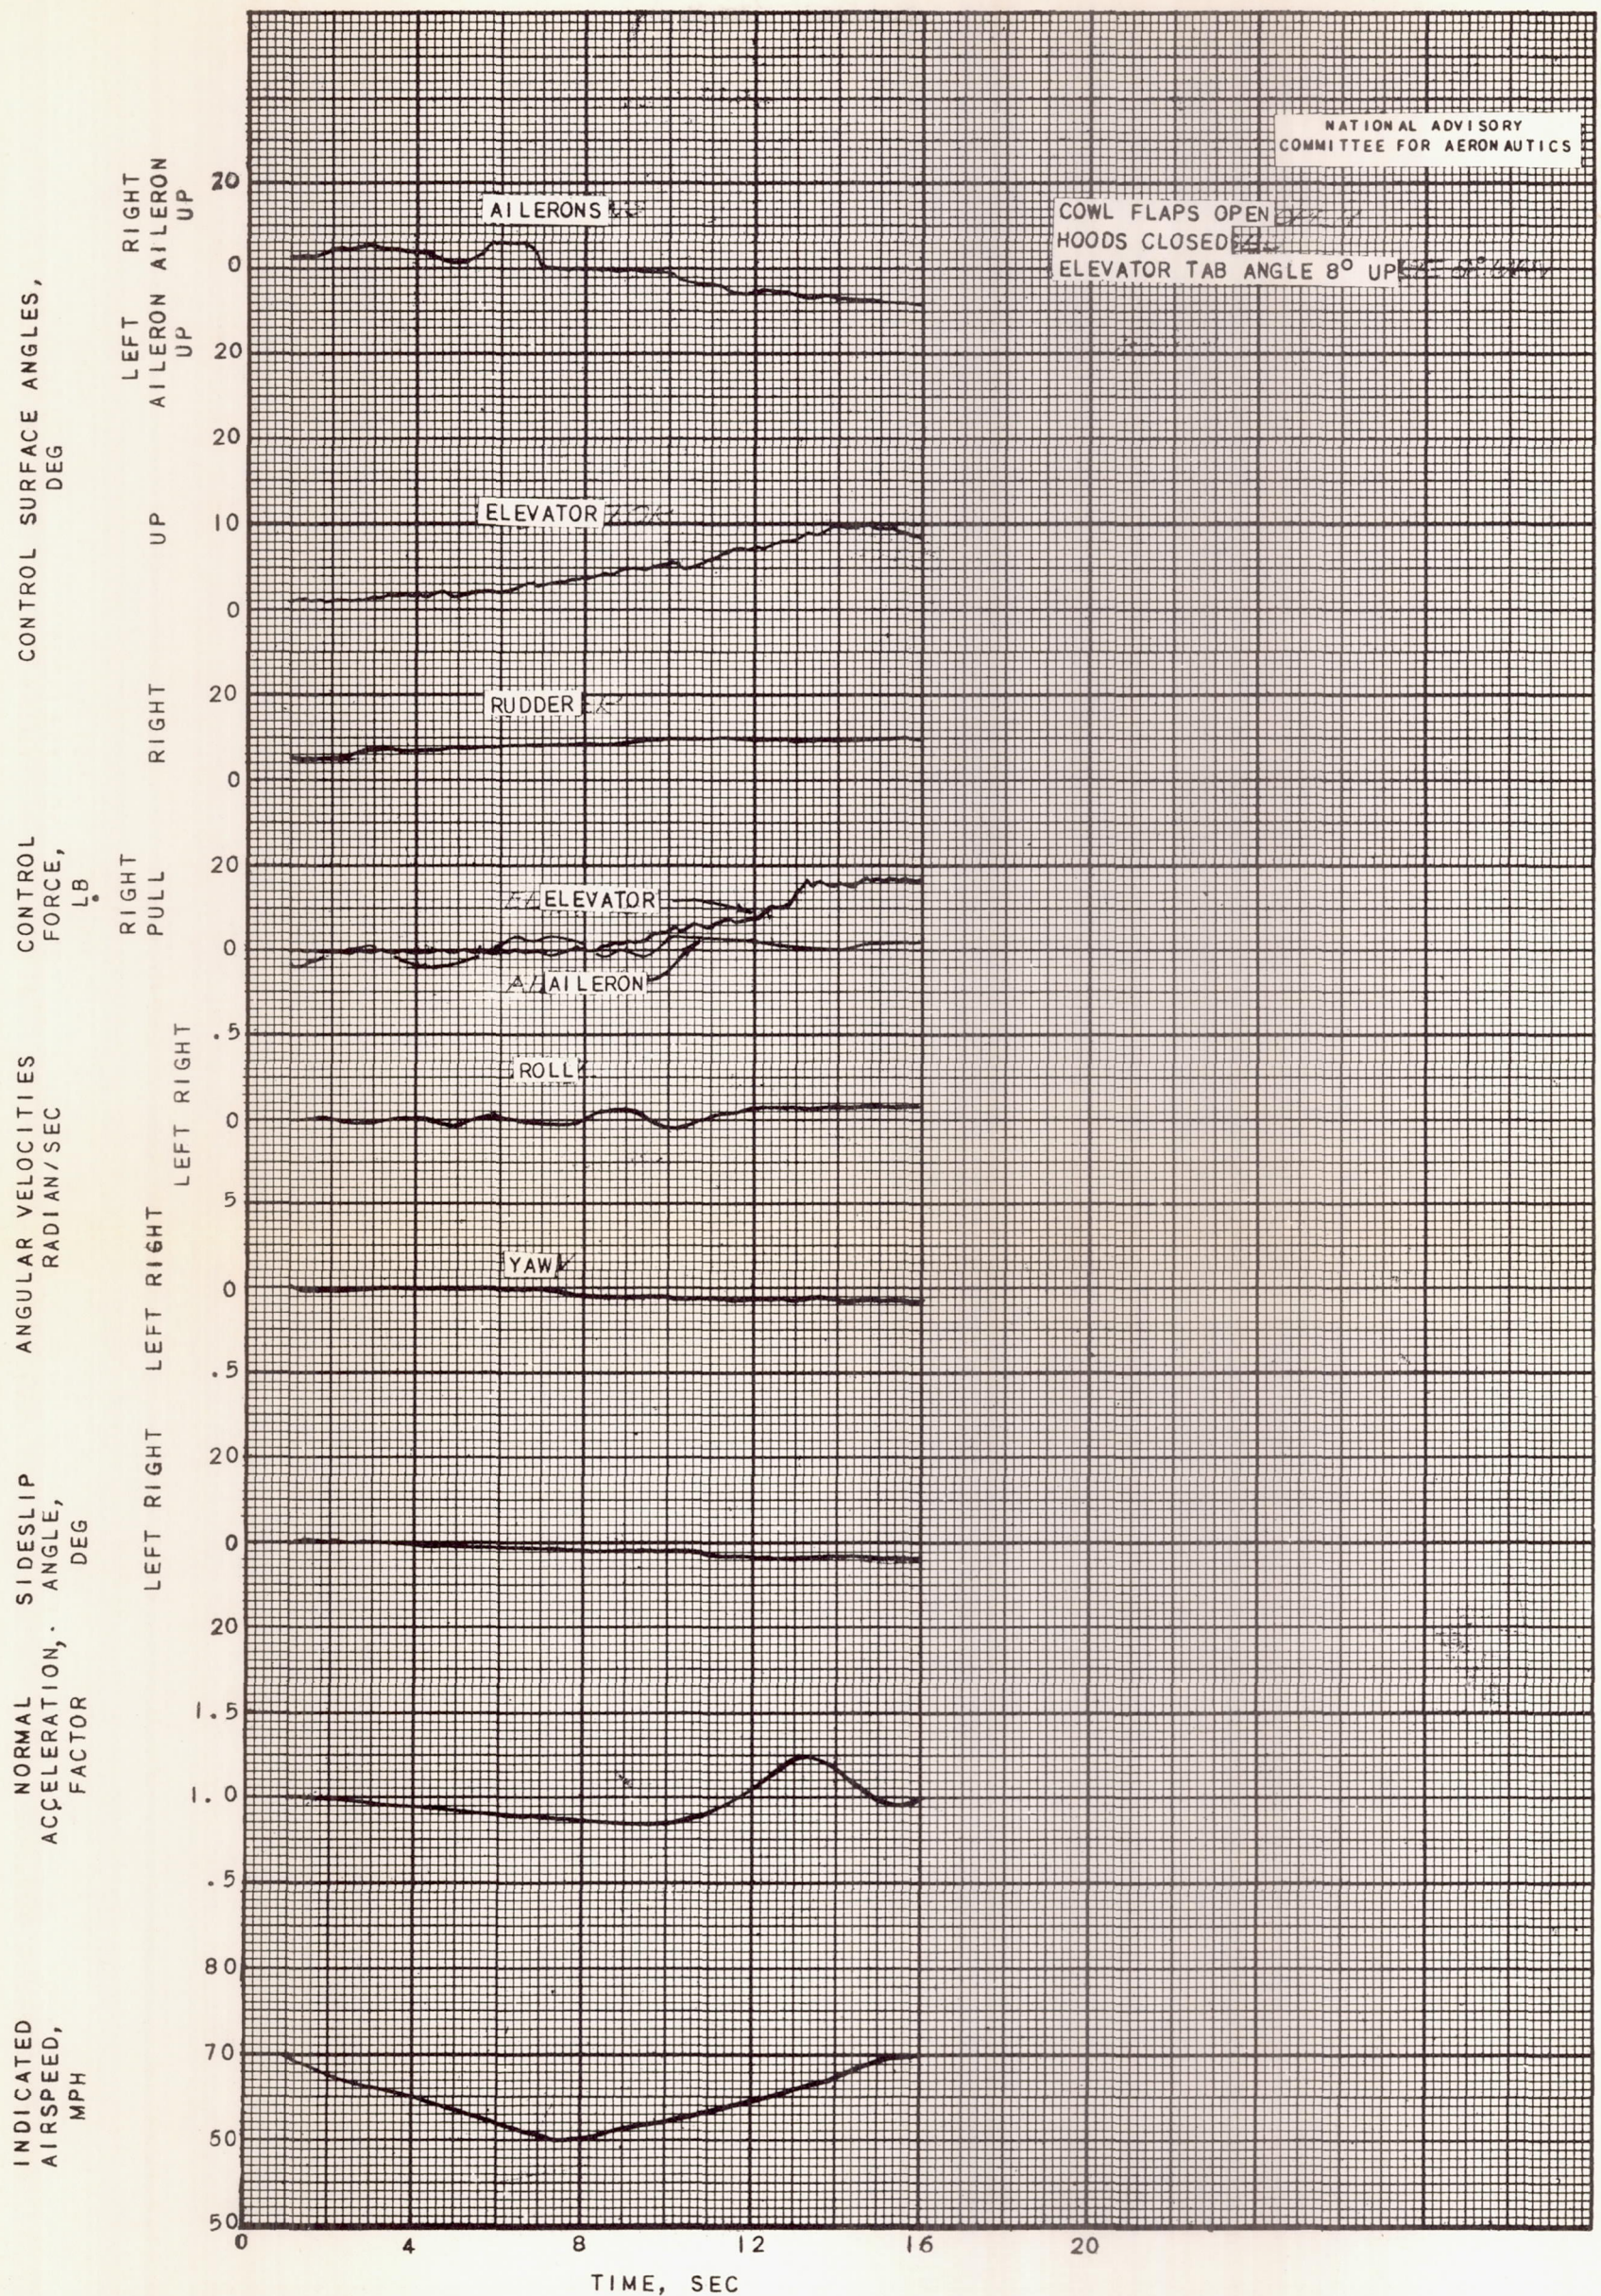
FIGURE 43. - TIME HISTORY OF A STALL, RATED POWER, FLAPS UP. STICK BACK AND HELD AT FIRST WARNING OF STALL; ATTEMPT MADE TO HOLD AILERON AND RUDDER FIXED.

FIGURE 44 - TIME HISTORY OF A STALL RATED POWER, FLAPS UP STICK FULL BACK. ATTEMPT MADE TO HOLD AILERONS AND RUDDER FIXED.

FIGURE 45. - TIME HISTORY OF A STALL, RATED POWER, FLAPS UP. STICK BACK TO STALL; AILERONS ALONE USED TO ATTEMPT CONTROL.

FIGURE 46.- TIME HISTORY OF A STALL, RATED POWER, FLAPS UP, STICK BACK TO STALL; RUDDER ALONE USED TO ATTEMPT CONTROL. AILERONS MOVED UNINTENTIONALLY.

FIGURE 47. - TIME HISTORY OF A STALL, RATED POWER, FLAPS ONE-HALF DOWN. STICK BACK AND HELD AT FIRST WARNING OF STALL. ATTEMPT MADE TO HOLD AILERON AND RUDDER FIXED.

FIGURE 48. - TIME HISTORY OF A STALL, RATED POWER, FLAPS ONE-HALF DOWN. STICK FULL BACK; ATTEMPT MADE TO HOLD AILERONS AND RUDDER FIXED.

FIGURE 49. - TIME HISTORY OF A STALL, RATED POWER, FLAPS ONE-HALF DOWN. STICK BACK TO STALL; AILERONS ALONE USED TO ATTEMPT CONTROL. RUDDER MOVED UNINTENTIONALLY.

FIGURE 50.- TIME HISTORY OF A STALL, RATED POWER, FLAPS ONE-HALF DOWN. STICK BACK TO STALL; RUDDER ALONE USED TO ATTEMPT CONTROL. AILERONS MOVED UNINTENTIONALLY.

FIGURE 51. - TIME HISTORY OF A STALL, RATED POWER, FLAPS DOWN. STICK BACK AND HELD AT FIRST WARNING OF STALL. ATTEMPT MADE TO HOLD AILERONS AND RUDDER FIXED.

FIGURE 52. - TIME HISTORY OF A STALL, RATED POWER, FLAPS DOWN. STICK FULL BACK; ATTEMPT MADE TO HOLD AILERONS AND RUDDER FIXED.

FIGURE 53. - TIME HISTORY OF A STALL, RATED POWER, FLAPS DOWN. STICK BACK TO STALL; AILERONS ALONE USED TO ATTEMPT CONTROL. RUDDER MOVED UNINTENTIONALLY.

FIGURE 54. - TIME HISTORY OF A STALL, RATED POWER, FLAPS DOWN. STICK BACK TO STALL; RUDDER ALONE USED TO ATTEMPT CONTROL. AILERONS MOVED UNINTENTIONALLY.

The stalling characteristics of the airplane for the various types of control and flight conditions investigated are indicated by the time histories of figures 43 to 66. The more important data and pilot's notes for these stalls are tabulated in table I.

From the recorded data, pilot's notes, and tuft studies it is seen that, for all of the flight conditions, the stall warning was adequate. Buffeting and shaking of the airplane and controls usually provided a definite warning before instability was reached. The instability experienced developed in a gradual but unmistakable manner and in most cases was accompanied by a marked increase in the elevator pull force and rearward travel of the control stick. After the complete stall had developed, it was possible to recover promptly by normal use of the controls. Thus, the stalling characteristics of the airplane in general appear to be satisfactory in relation to the requirements of reference 3.
